ARMY RESEARCH LABORATORY

Examination of BSU-86/B Setscrews

ARL-MR-379

NOVEMBER 1997

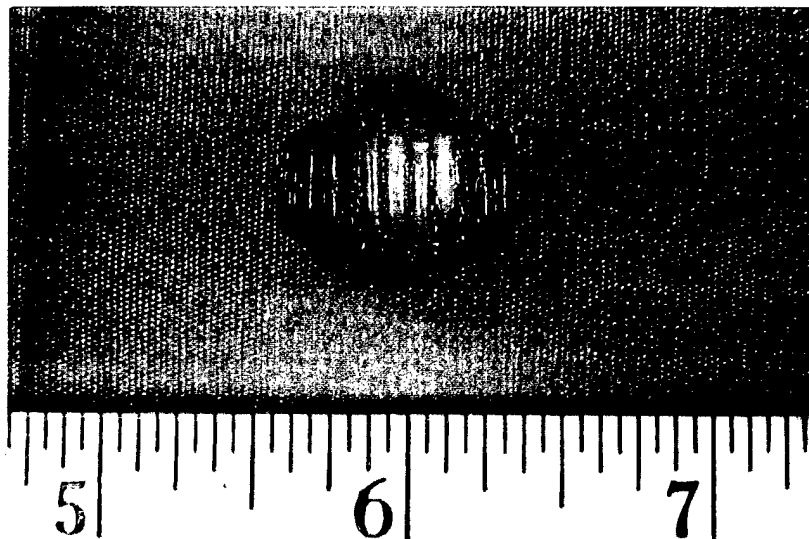
Figure 3. Representative New Setscrew in the As-Received Condition.

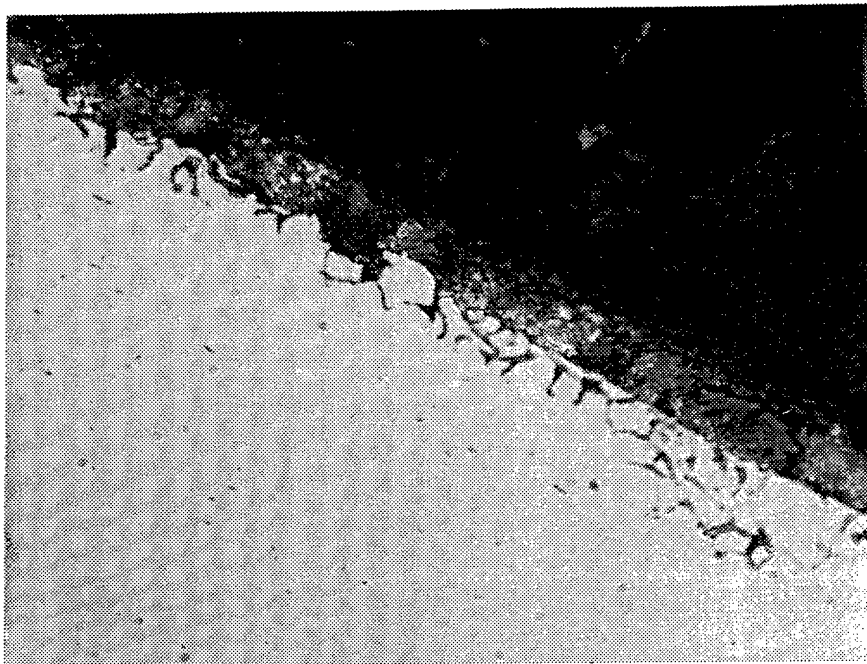
Metallography was used to confirm the presence of decarburization along the periphery of the setscrews. The setscrews that were sectioned and mounted for microhardness testing were subsequently metallographically prepared. The samples were first examined in the as-polished condition. The samples were relatively clean and exhibited no appreciable inherent material defects. Some surface laps were noted in the roots of some threads, as shown in Figure 6. This particular lap was found in a thread root of setscrew N1. Along the surface of the samples, areas of microcracking were also noted. These cracks were filled with cadmium, which indicated that they were present before the plating operation. The amount of cracking varied from setscrew to setscrew, as well as from thread root to thread tip. This cracking was not noted along the socket surfaces. The cracking along a thread flank of the U1 setscrew is shown in Figure 7, which represented the worst case

scenario. This cracking was heavier than that noted along the flank of the U4 setscrew (see Figure 8). Table 5 summarizes the extent of the cracking noted. No comparison could be drawn between the used versus the new setscrews; however, the heaviest areas of microcracking correlated to the regions of heaviest decarburization.

Figure 7. Microcracking Noted Along a Thread Flank of Setscrew U1 (magnification 1000x).

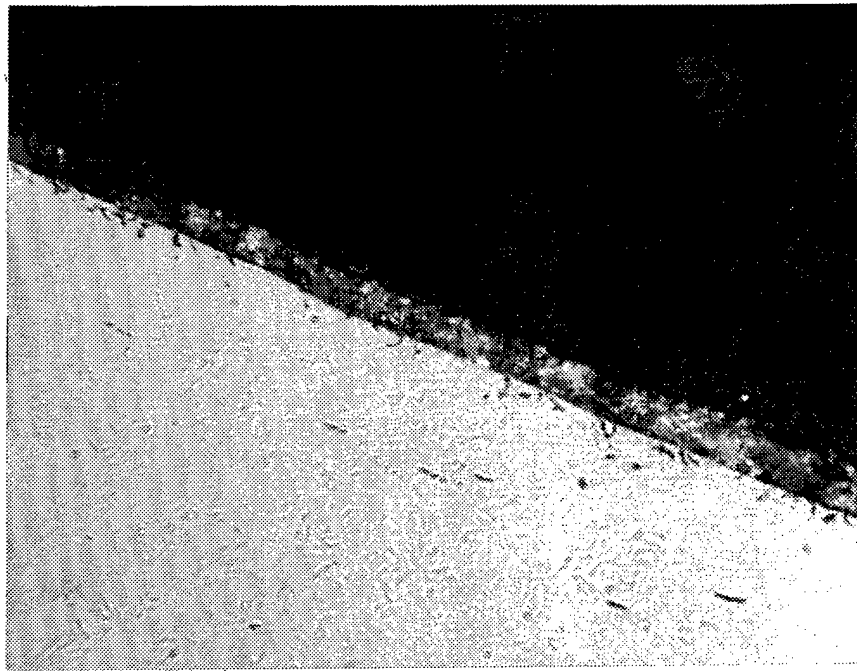
Figure 8. Microcracking Noted Along a Thread Flank of Setscrew U4 (magnification 1000x).

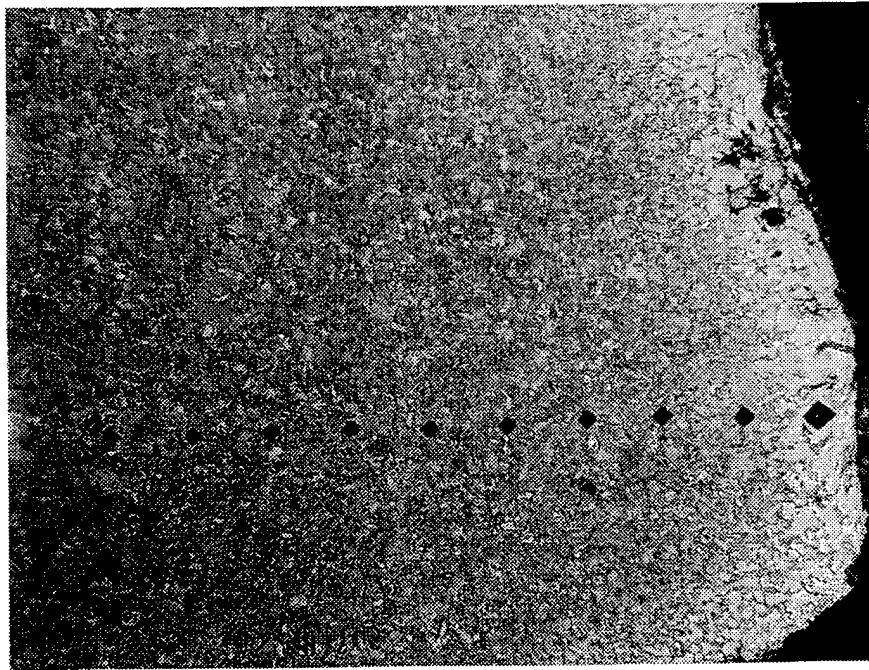
Figures 9 through 12 show the Vickers microhardness profiles taken from the thread tips of U1, U4, N1, and N2, respectively. Note that the setscrews with the heaviest amount of cracking (see Table 5) also exhibited the lowest surface hardness (see microhardness results) and the heaviest amount of surface decarburization (see Figures 9 and 12). Figure 13 shows a magnified view of the hardness indents at the tip of the thread of U1. Note that the indent located within the decarburized layer (white layer) is larger than the other indents. This shows that the decarburized layer is much softer than the transition zone and core. Figure 14 shows the decarburized layer at the thread tip of N2. Figures 15 through 18 show the hardness indents at surface of the socket for U1, U4, N1, and N2, respectively. Note the decarburization on U1 (see Figure 15) and N2 (see Figure 18).

Figure 9. Vickers Microhardness Profile Along the Tip of a Thread From Setscrew U1. (Note the layer of decarburization along the tip of the thread; magnification 200x.)

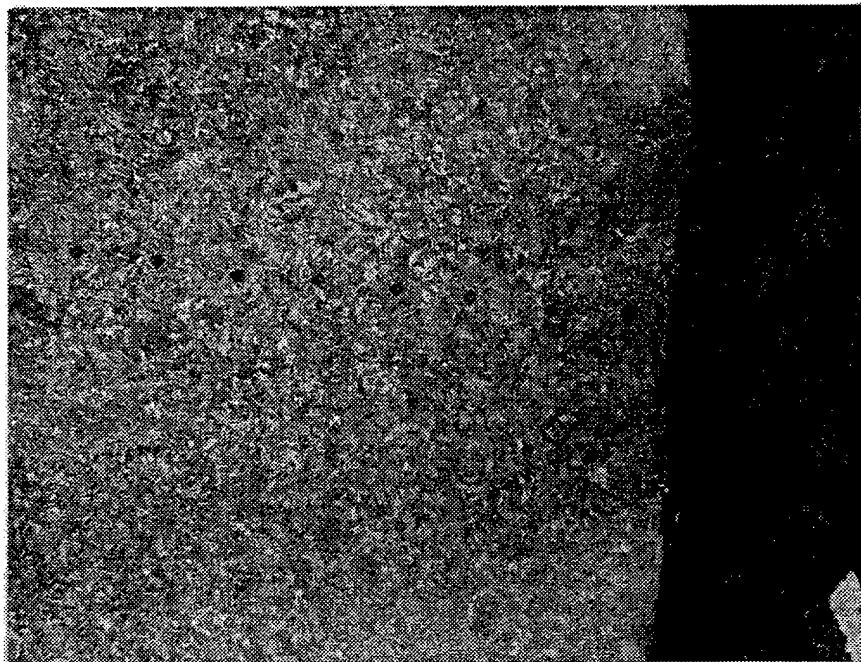
Figure 10. Vickers Microhardness Profile Along the Tip of a Thread From Setscrew U4 (magnification 200x).

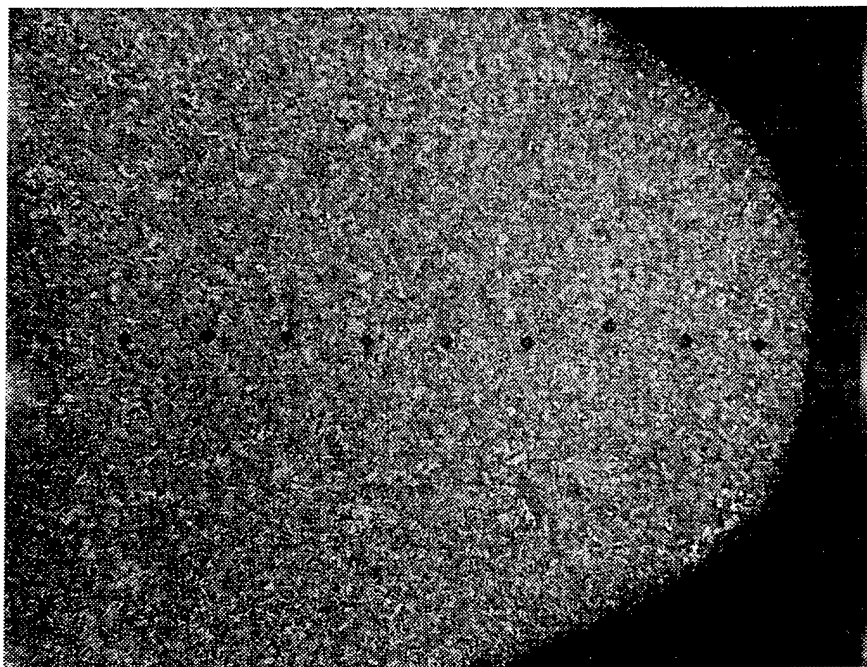
Figure 11. Vickers Microhardness Profile Along the Tip of a Thread From Setscrew N1 (magnification 200x).

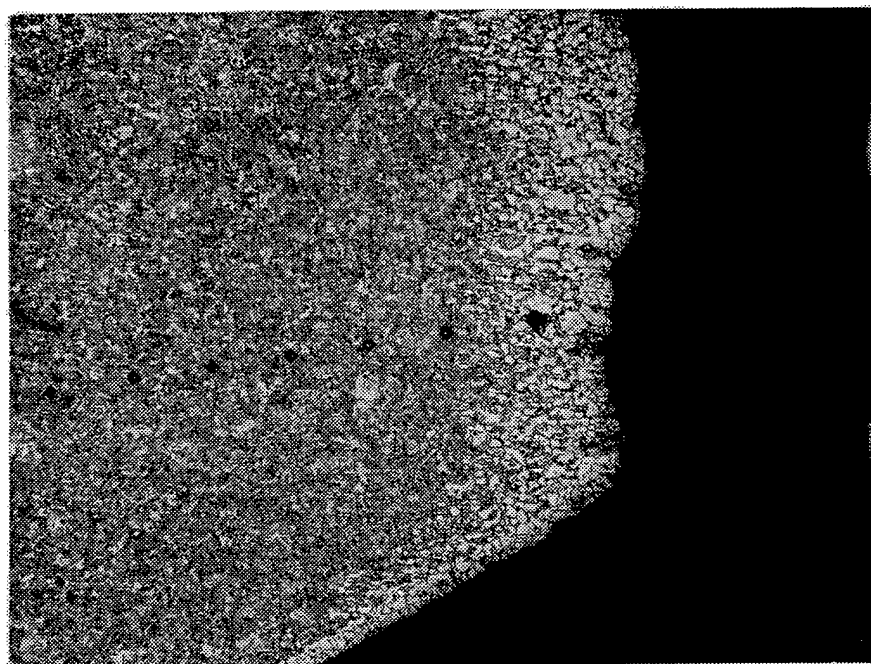
Figure 12. Vickers Microhardness Profile Along the Tip of a Thread From Setscrew N2. (Note the layer of decarburization along the tip of the thread; magnification 200x.)

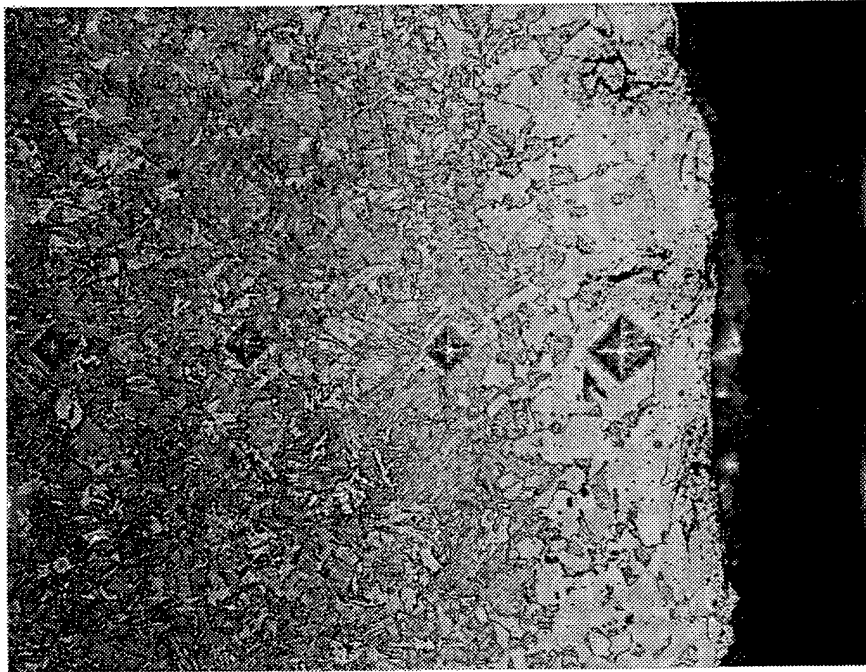
Figure 13. Vickers Microhardness Profile Along the Tip of a Thread From Setscrew U1 at Higher Magnification. (Note the larger indent within the decarburized layer indicating a softer material; magnification 500x.)

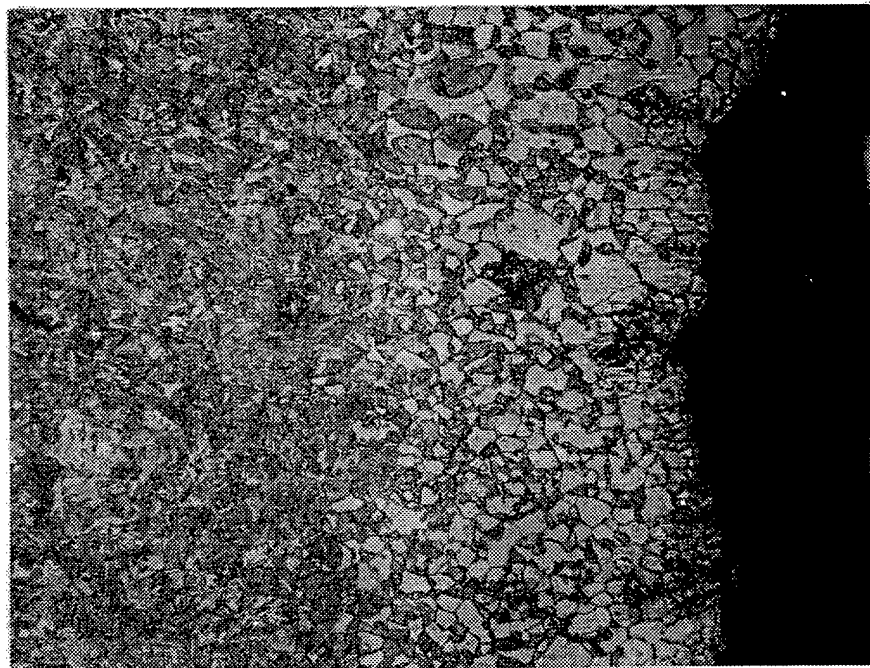
Figure 14. Vickers Microhardness Profile Along the Tip of a Thread From Setscrew N2 at Higher Magnification. (Note the larger indent within the decarburized layer indicating a softer material; magnification 500x.)

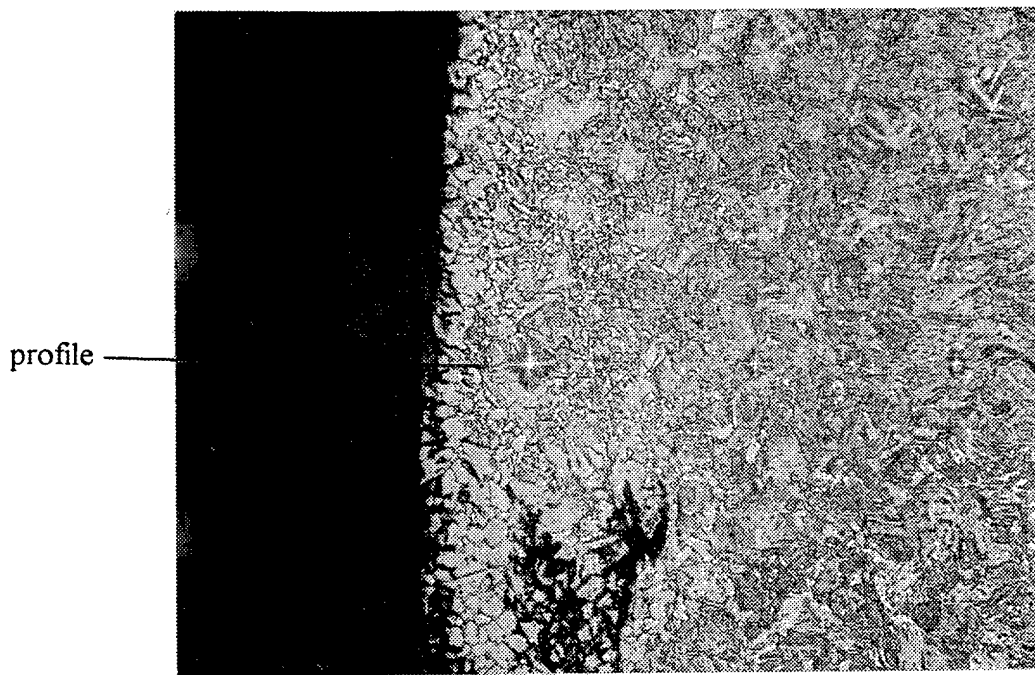
Figure 15. Vickers Microhardness Profile Along the Socket of Setscrew U1. (Note the larger indent within the decarburized layer indicating a softer material; magnification 500x.)

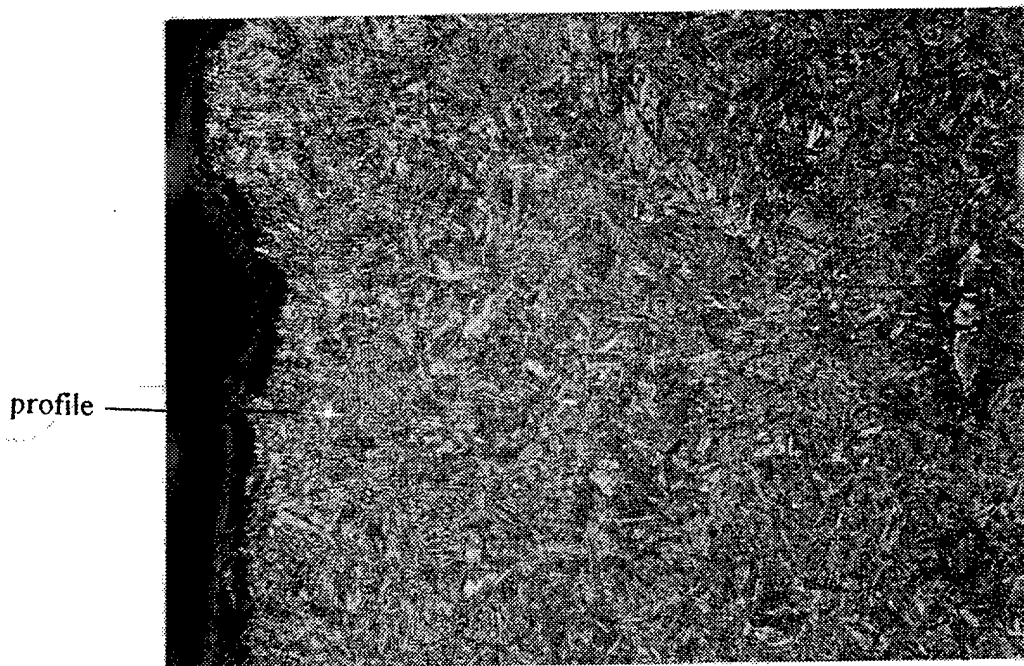
Figure 16. Vickers Microhardness Profile Along the Socket of Setscrew U4. (No decarburization was present on the socket surface; magnification 500x.)

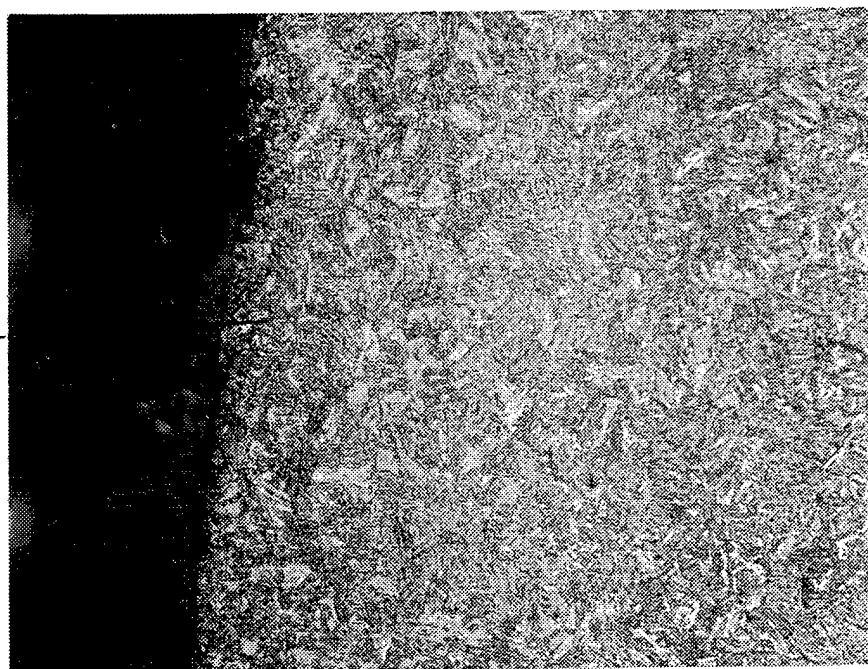
Figure 17. Vickers Microhardness Profile Along the Socket of Setscrew N1. (No decarburization was present on the socket surface; magnification 500x.)

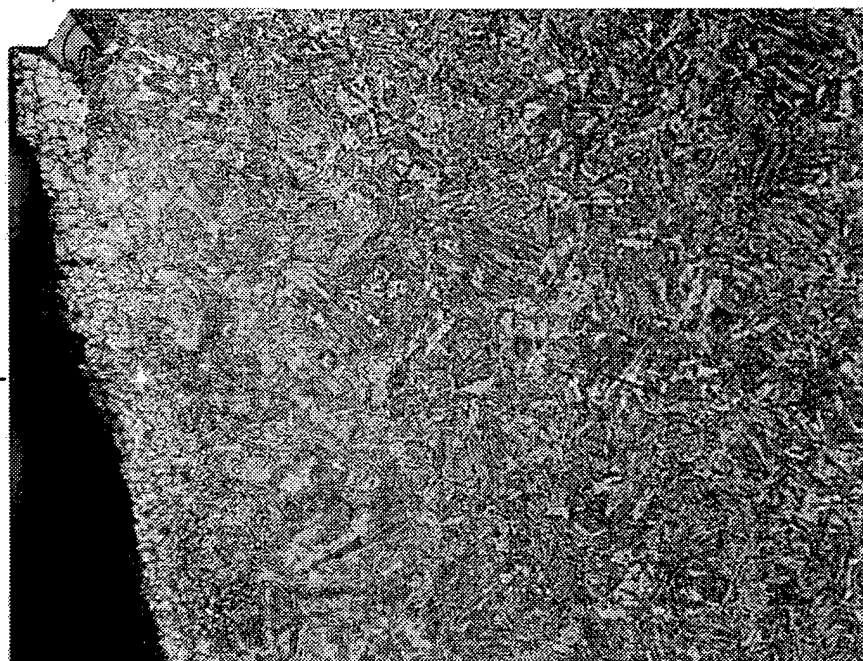
Figure 18. Vickers Microhardness Profile Along the Socket of Setscrew N2. (Note the larger indent within the decarburized layer indicating a softer material; magnification 500x.)
